Road Safety Audit of RBVRR TSPA Junction – Moinabad Town

^{1,2}N. Naveen, ³Dinesh Kumar Yadav
¹Assistant Professor, K G Reddy College of Engineering and Technology, Hyderabad, India
²(Research scholar, VELS University, Chennai, India)
³(CEO, Texture Engineering Blueprints LLP, Nagpur, India)

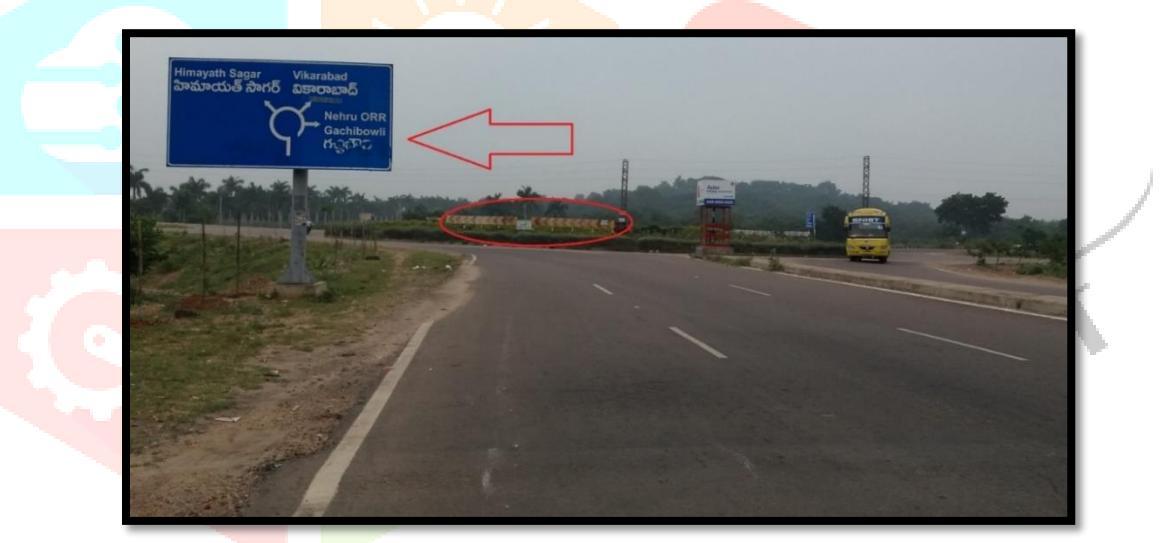
Fig 2 Retroreflective diversion boards faded

Chevron sign placed at the roundabout were faded. Direction sign board placed at the shoulder is very near to the carriageway. Reason for Concern:

Faded sign board can't be seen during nights and driver may not know that he is going to approach the roundabout. Directional sign board causing the blind spot and as it near to the carriageway it may hurt the vehicles or the passengers sitting at the windows. Recommendation:

New Chevron sign boards should be placed. Directional sign board should be placed adequate distance from the carriageway so that heavy vehicles will feel comfort while maneuvering.

Priority: Highly Essential

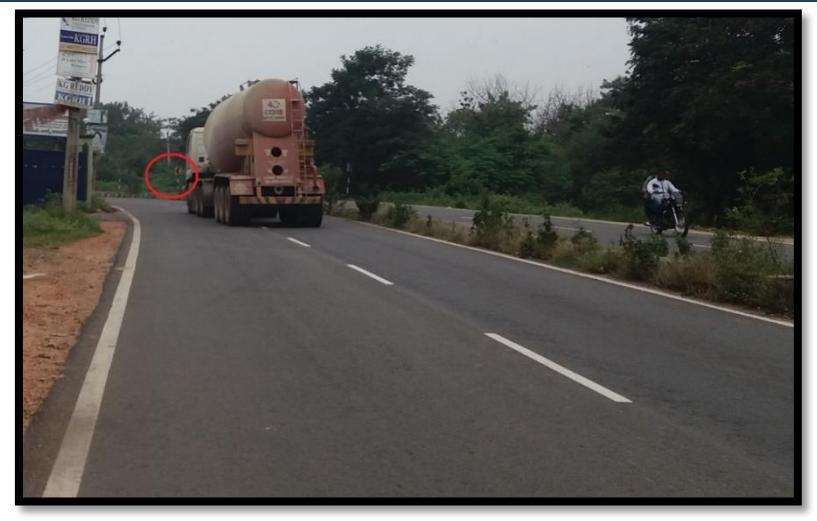
Fig 3 Horizontal curve clearly indicated by retroreflective Chevron signs.

Chevron sign placed clearly

The signs will illuminate by the vehicle lights and give indication about the horizontal curve of the road.

Provision of these signs is a better idea for safety during nights.

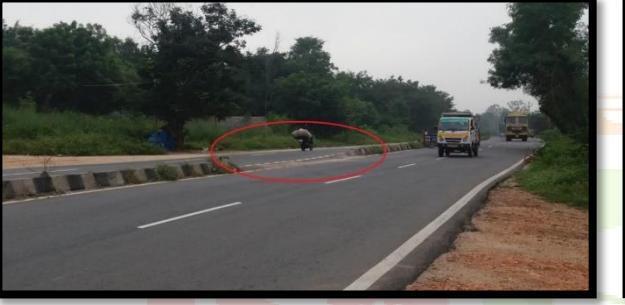
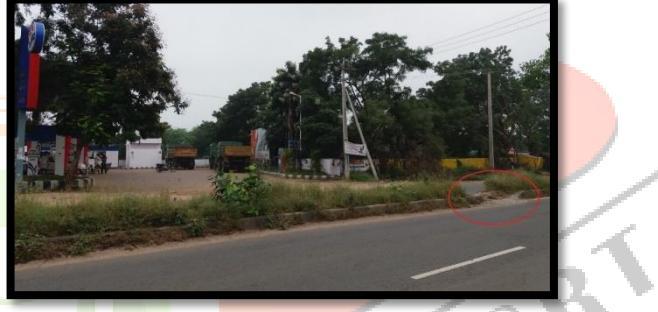
Fig 4 Illegal/ wrong/incorrect opening in the median.

Illegal median opening on the straight road for personal purpose likely to result in serious accidents. Reason for Concern:

Causes disturbance to the vehicles coming with a greater speed. They even cause delay in the travel time and unrest in the driver's mind moving on the highway. These median openings cause frustration in drivers and become accident black spots. Recommendation:

These types of medians should be closed. Priority: Essential

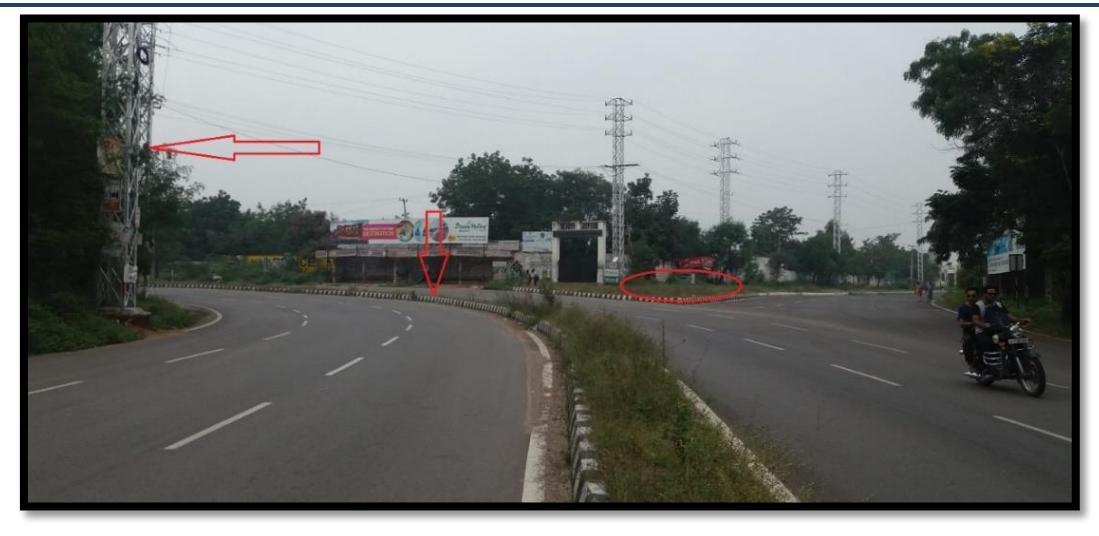
Fig 5 signing boards were not placed to guide the turning.

Electrical post placed near the carriageway. Absence of the illumination and chevron sign board at a busy intersection. Reason for Concern:

Electrical post can be a hazard during turning. Dark area at this intersection causes confusion to the drivers as it is a well channelized island. Recommendation:

Electric pole should be removed/ relocated to less hazardous location. Chevron sign boards should be placed or else at least directions markings should be done on the road to indicate the turning provisions. This can control the drivers passage through conflict points or sections. Reflecting studs should be installed for night time driving

Priority: Highly Essential

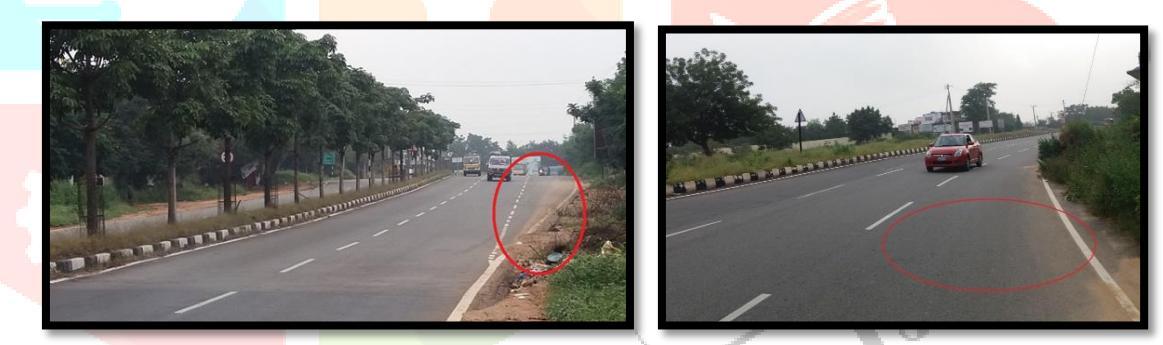
Fig 6 Extra lane provided.

Nice extra lane is provided at curve with good road markings

This lane gives time to the drivers to enter in to the main carriageway after encountering curve.

Maintenance of this extra lane is must at the curve and turning places

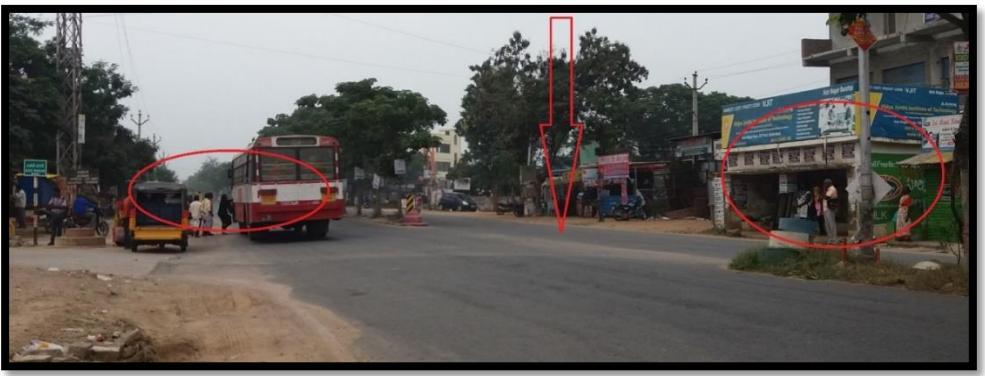
Fig 7 Bus stops on the main road.

Road markings missing. Lack of pedestrian facilities and bus stops placed exactly at the junction

Road markings should be there to guide the traffic and lane division. Zebra crossings should be there for the safety of pedestrians. Bus stops causes traffic jams on the highway and even accidents

Proper road markings should be given on the road. Zebra crossing, and bus stops should be placed 60 meters away from the junction Priority: Highly Essential

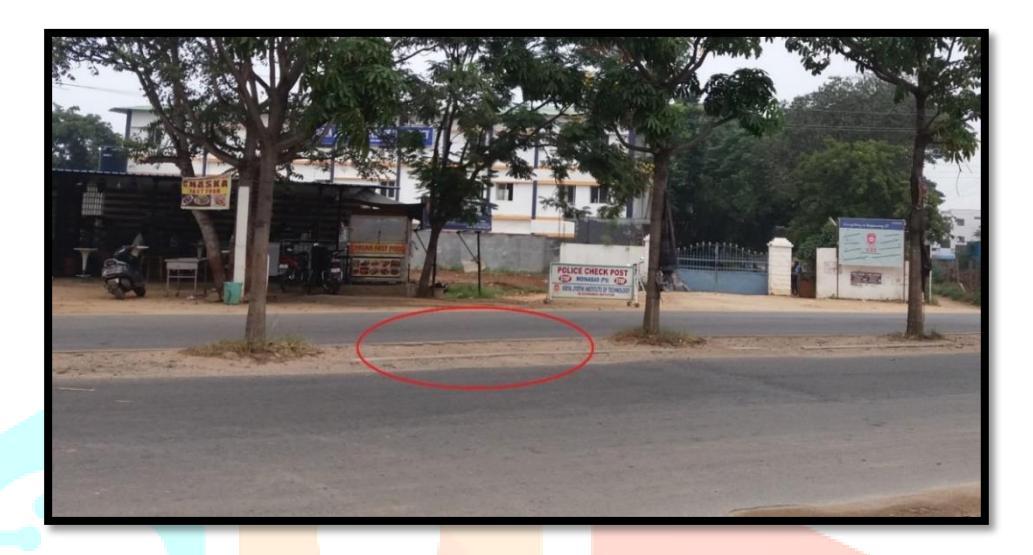
Fig 8 Median at the carriageway level.

Median height level is at the carriageway height. This is insufficient or deficient treatment of the median. Reason for Concern:

Traffic violators may cross the road easily as the level of carriageway is same as kerb. This causes disturbances to the drivers and may lead to crashes

Kerb height of 15 centimeters should be maintained to curb the traffic violations

Priority: Essential

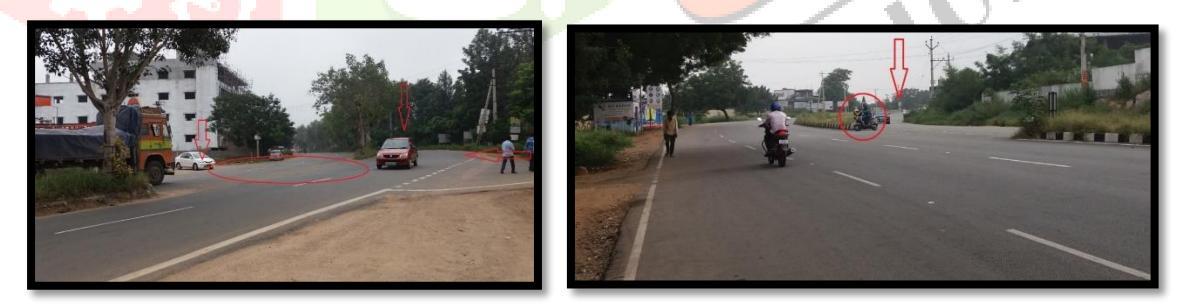
Fig 9 Median opening at the steep curve.

Median opening at the sharp curve creating confusion to the highway drivers. This is incorrect or misplaced treatment. Uncontrolled access to premises abutting a main road can substantially impede traffic flows and create severe road safety hazards as vehicles tempt to leave, merge with cross traffic streams.

It's like a junction main highway on the both directions, to its sides a minor road and the other side with the busy petrol bunk. The turnings from the petrol bunk and the minor road causes disturbances to the highway vehicles at the sharp curve and this causes sudden braking and nose to tail accidents, side by side collisions.

Median should be closed at this point and this facility can be done at a straight road.

Priority: Highly Essential

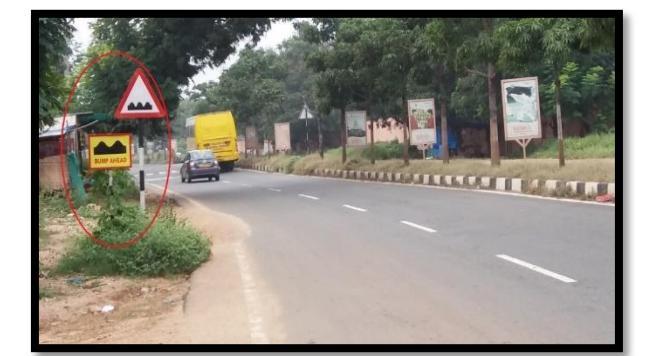
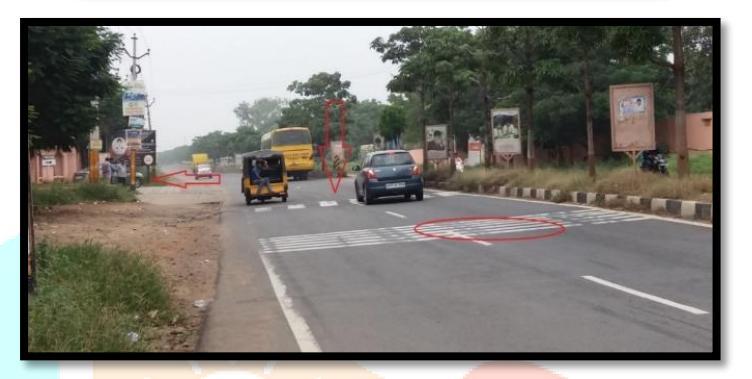
Fig 10 Indication of speed breakers.

Indication of speed breakers and wrong placement of speed breakers, it's an incorrect and misplaced treatment. Reason for Concern:

Speed breakers are clearly indicated prior with sign post and markings. As it is a highway there should be no speed breakers. Recommendation:

Speed breakers should be removed from the point along with sign post indicating the speed breakers.

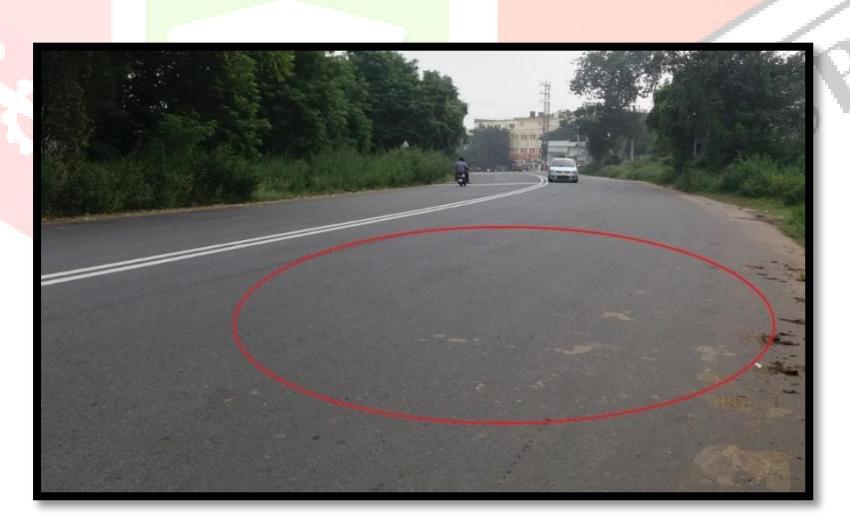
Fig 11 Absence of Super Elevation.

Absence of super elevation and markings on the outer curve.

Vehicles may run out from the road at curves when there is no proper super elevation

Proper super elevation need to be provided so that the road can be forgiving of the drivers errant or inappropriate behavior. Studs should be used on the center line and edge of the carriageway which guides the driver during nights. Priority: Highly Essential

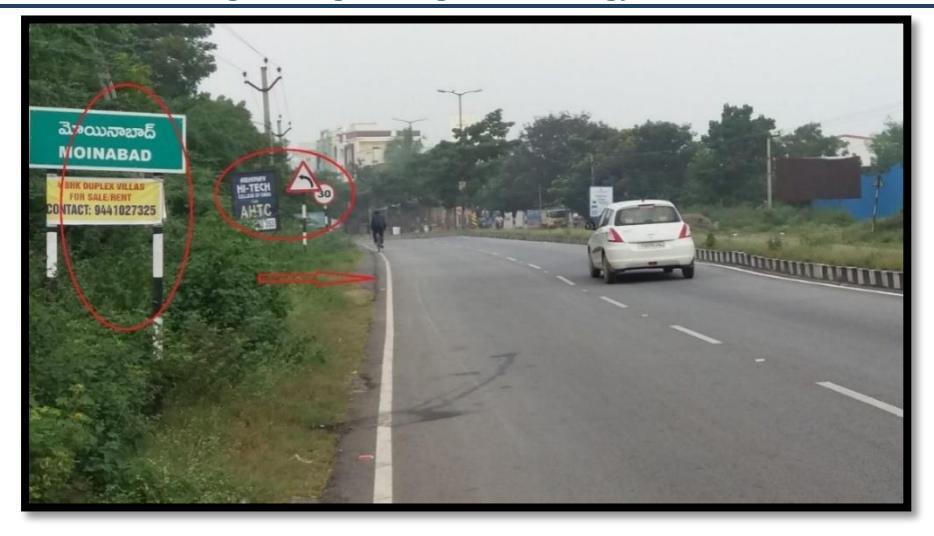
Fig 12 Inadequate and incomplete signage results in confusion.

Sign boards and advertisement boards creating confusion on driver's mind. Provision of sign boards at a shorter distance and poor maintenance of the shoulder

The three sign boards indicating the place, curve, speed was at a shorter distance less than 10 meters distance between them. some advertisement boards along with the sign boards creates confusion to the drivers.

The 10 meters distance between the sign boards should be maintained and the advertisements boards need to be removed. Priority: Essential

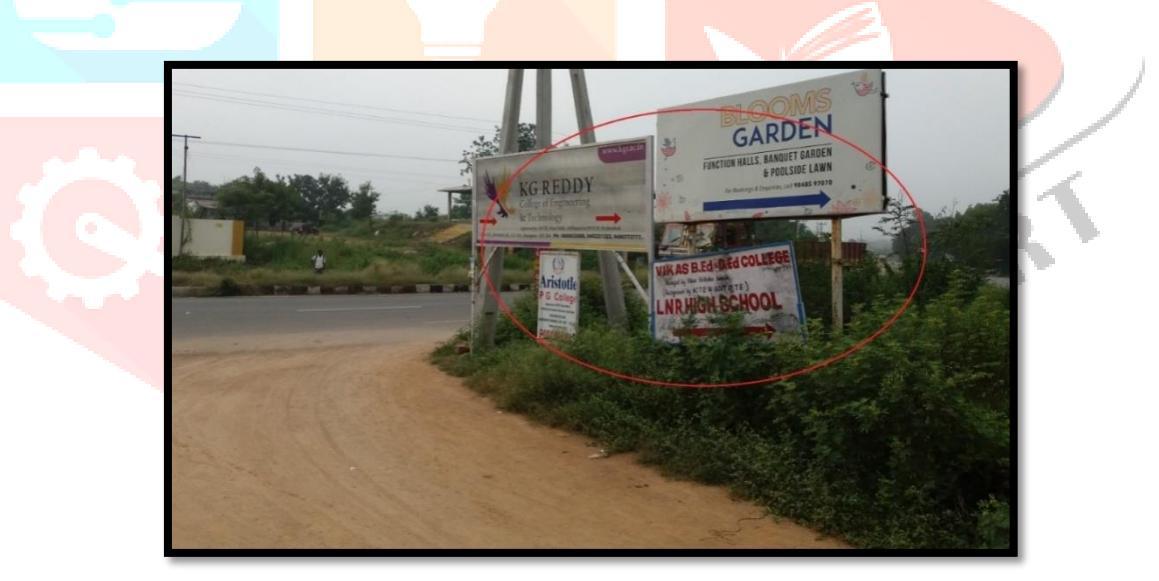
Fig 13 Route indicating boards causing blind spots.

Immoderate treatment of Route signs causing blind spots for the major and minor roads.

These blind spots are the cause for the accidents. As this is the college area students ride their bikes without noticing the vehicles coming from the major roads during turnings.

Directional sign boards need to be removed or placed some distance back giving a clear angle vision.

Priority: Highly Essential

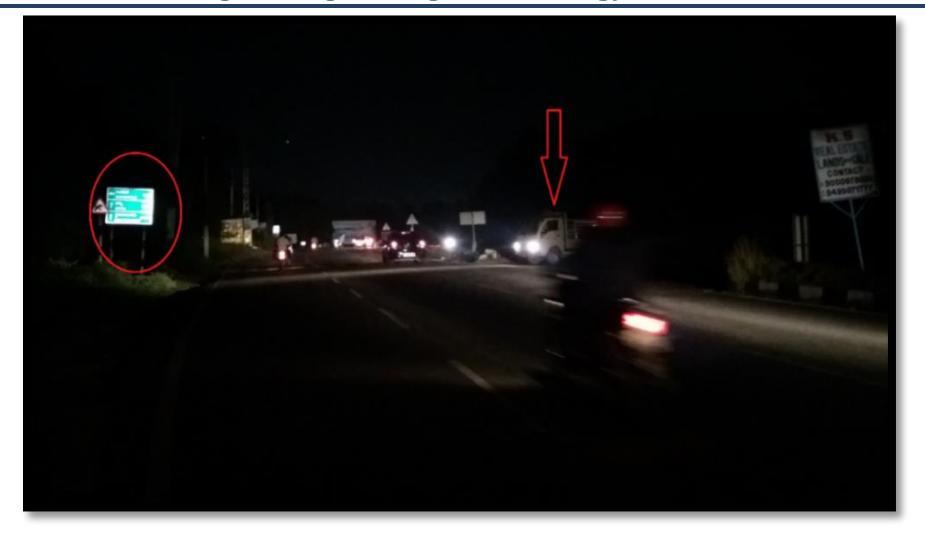
Fig 14 A junction with low illumination and wrong median break.

A junction with low illumination and wrong median break.

The low visibility at the junction and the median break near the junction may be a hazardous and cause sudden braking and nose – to – tail accidents. Recommendation:

Median should be closed and be provided at farer place away from the intersection. Illumination of the junction should be done with high standard of street lighting. This causes frustration in drivers and becomes accident black spots.

Priority: Highly Essential

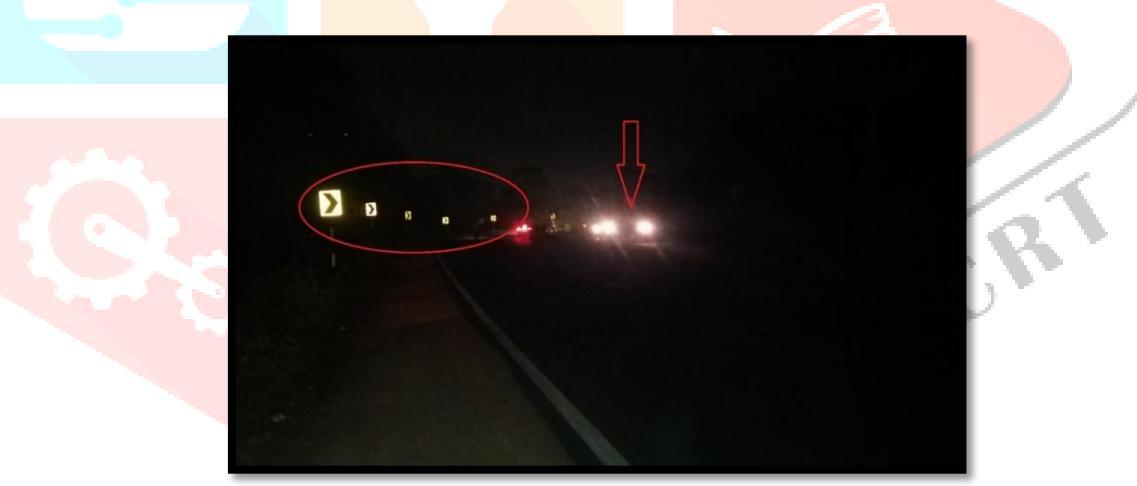
Fig 15 chevron sign boards illuminated at the curve.

Chevron sign placed at the correct place. Light rays of the opposite vehicles causing glare to the drivers

The signs should be used at every curve and this is highly recommended at the curves to give information about the curve

Median should be raised with small plants to obstruct the lights from opposite direction/ the median width need to be increased up to 2 meters/ Glare screen can be used.

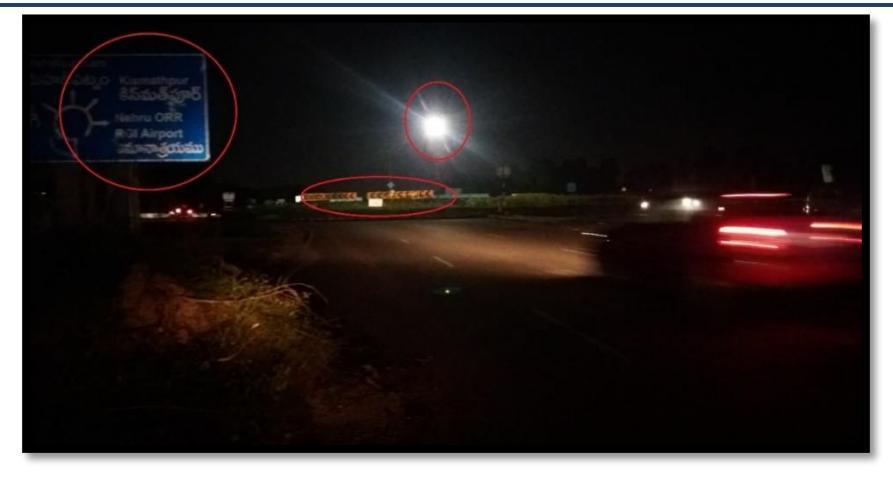
Fig 16 Chevron sign boards clearly indicating the turning.

Chevron sign boards clearly indicating the turning.

The signs clearly indicating the roundabout with directional signs.

Retro reflective signing increases Night time safety.

Priority: Highly Essential
