EARTHQUAKE INDUCED LIQUEFACTION AROUND THE WORLD

Abstract: In this paper we have briefly studied effects of liquefaction on different locations around the world, specifically those places where earthquakes are the major reason for liquefaction to occur, as liquefaction is a major determining factor in longevity and stability of the entire structure during various situations that lead to liquefaction.

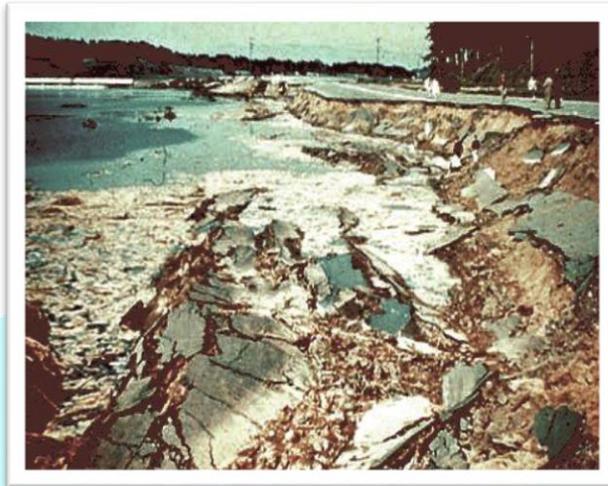
Lake Merced, road slid down due to SF earthquake in 1957

- i. The effects of liquefaction may include major sliding of soil toward the body slumping and sliding of water, as was the case of 1957 Lake Merced slide
- ii. In case of banks of Motagua, the tension cracks were introduced in the aftermath of the Guatemala earthquake back in 1976. The earthquake hit with a of 7.5 on Richter scale causing more than ten thousand landslides in total.

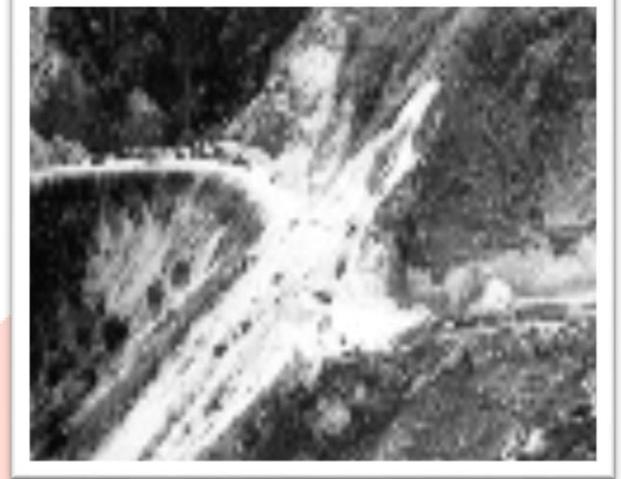
Highway blocked by landslide in Guatemala Earthquake

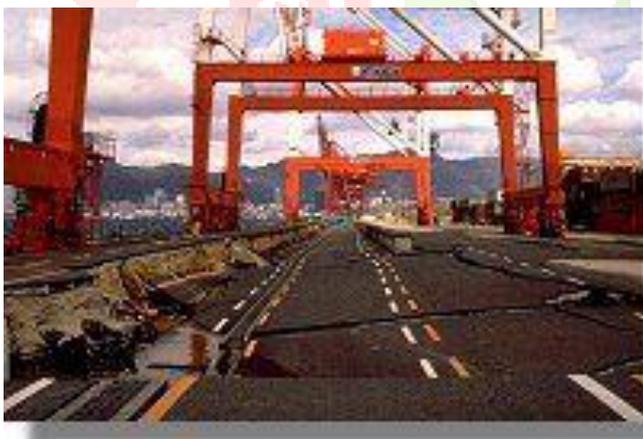
Lateral displacement of a quay wall, Kobe 1995

- iii. Liquefaction caused major damage to port facilities in Kobe, Japan in the 1995 Hyogo-ken Nanbu earthquake. It is also referred to as The Great Hanshin earthquake

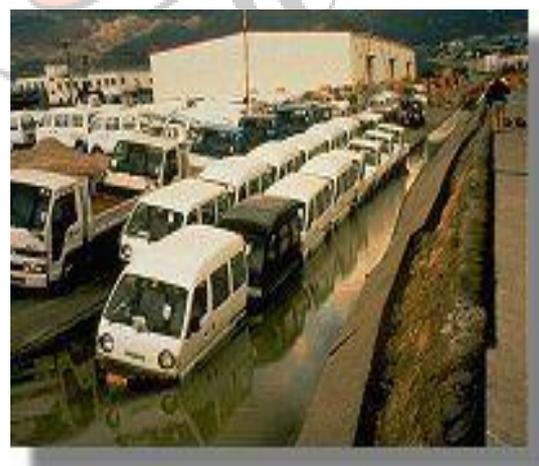
1.2-2m drop in paved surface and flooding

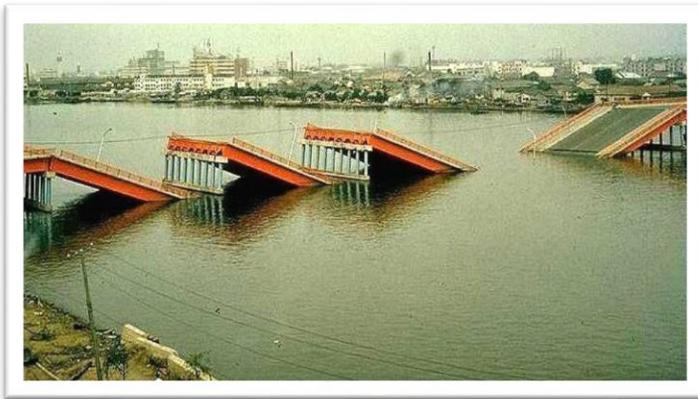
Loss of support due to sliding of soil during earthquake

Liquefaction also frequently causes damage to bridges that cross rivers and other bodies of water. Such damage can have drastic results. Liquefaction-induced soil movements can push foundations out of place to the point where bridge spans loose support or are compressed to the point of buckling.

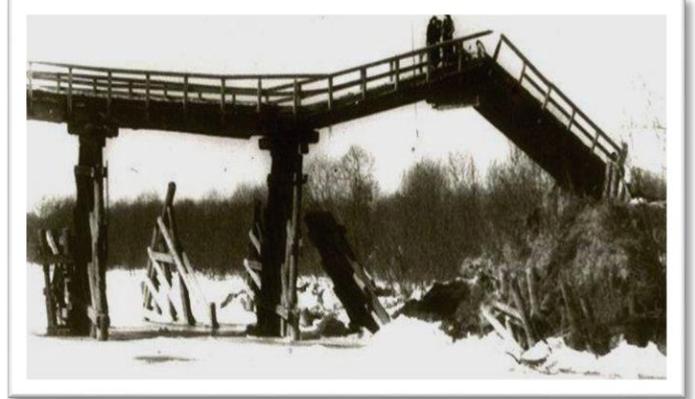
Buckling of bridge due to compression induced by earthquake

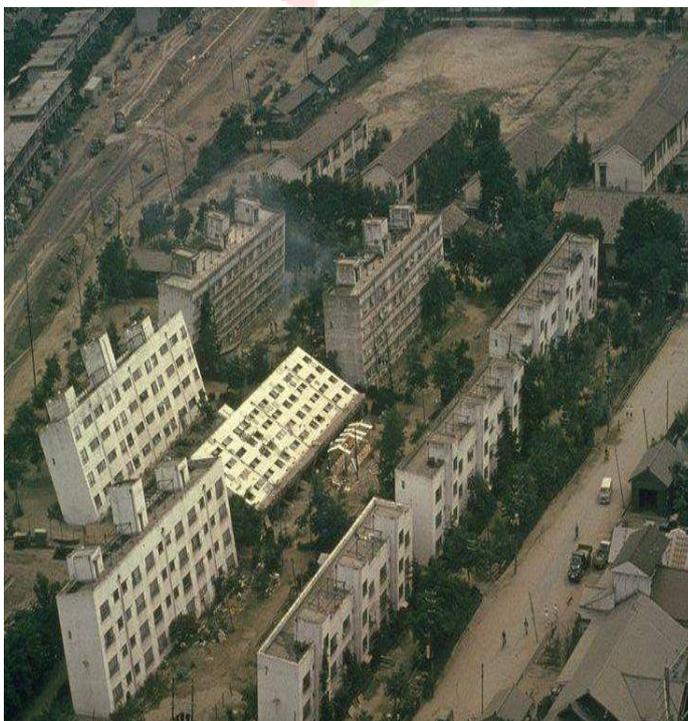
A significant ground failure occurred near the Shinano river bank where the Kawagishi-cho apartment buildings suffered bearing capacity failures and tilted severely (left image below). Considering the extreme tilting, the buildings

- iv. The Niigata earthquake that hit on June 16, 1964 had a magnitude of 7.5 on Richter scale caused severe damage to many structures in Niigata. The destruction was observed to be largely limited to buildings that were built on top of loose, saturated soil deposits prone to liquefaction. Even though about 2000 houses were destroyed, only 28 lives were lost. A tsunami, caused by movement of the sea floor associated with the fault rupture, completely the port of Niigata.

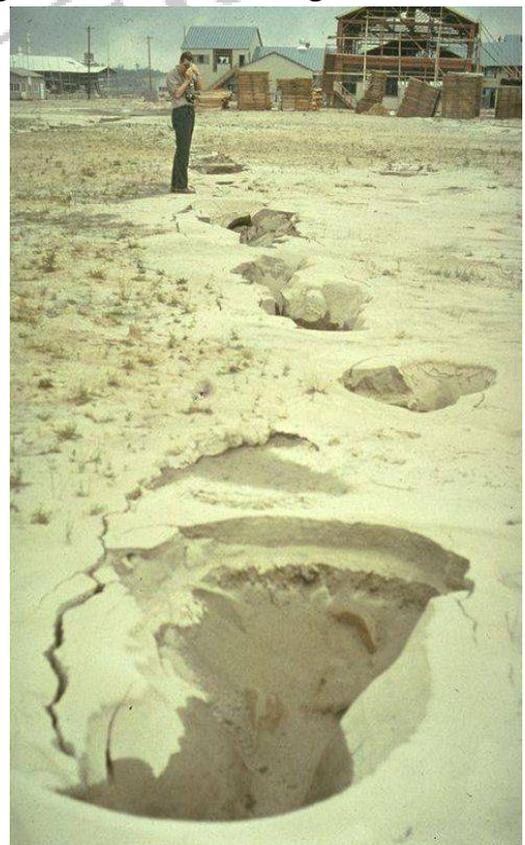
themselves suffered relatively less damage. Sand boils and ground fissures were observed at various sites in Niigata (right image below).

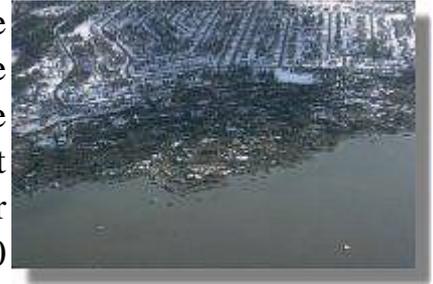
- v. Being a part of the Pacific Ring, the southern coast area of Alaska experiences many earthquakes. On March 27, 1964, a great earthquake of magnitude 9.2 struck Prince William Sound and caused severe damage in the form of landslides and liquefaction (image to the right). This seismic event is the second largest ever to have been recorded and it lasted for over 3 minutes. It was felt over an area of 500,000 square miles. A tsunami, heavily increased the amount of damage to wharf and waterfront facilities.

Liquefaction in sand layers, and in sand and silt seams in the clayey soils beneath Anchorage, caused many of the destructive landslides that occurred during the earthquake.

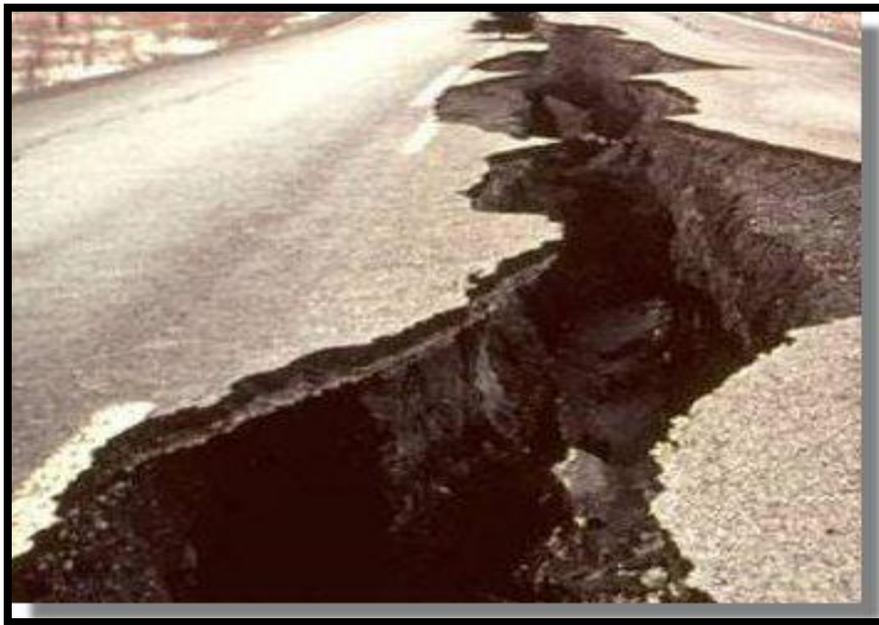
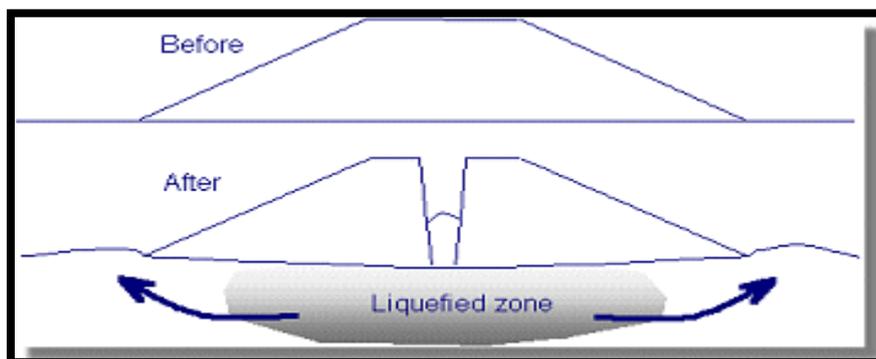
Lateral spreading in the soil beneath the roadway embankment caused the embankment to be pulled apart, producing the large crack down the center of the road.

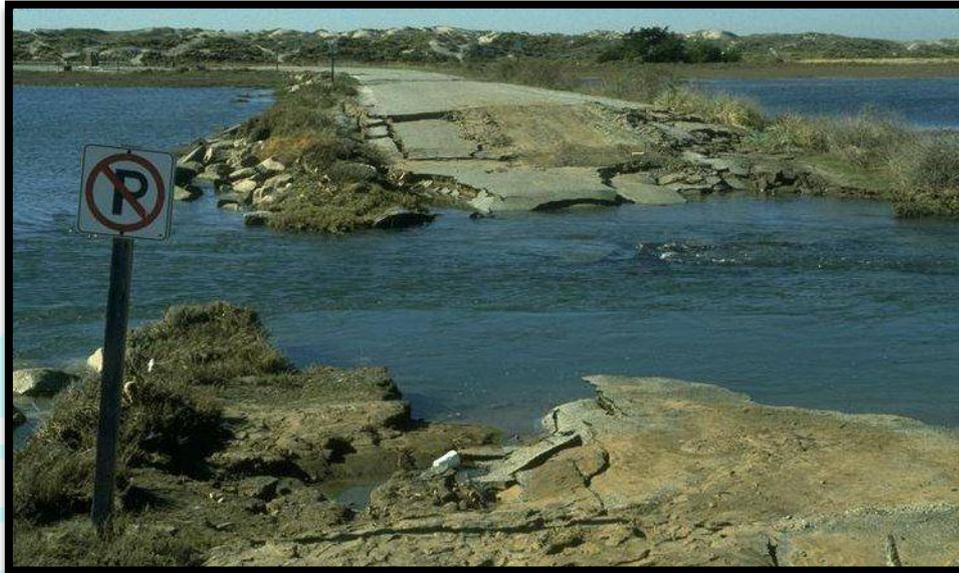
Soil liquefaction caused major damage to waterfront facilities, structures, and buried pipelines at locations in the Bay Area where loose saturated, sandy soils were susceptible to liquefaction. The numerous sandboils that were observed provided indisputable evidence of the occurrence of liquefaction. Liquefaction was observed at a number of sites, including the Oakland airport, sites along the Salinas River, and Moss Landing Marine Station.
