Sustainable Retrofitting Of Fire Damaged Cement And Geopolymer Concrete Slabs Using Hybrid Basalt And Carbon Fiber Reinforced Polymers.

¹Chethan Kumar S, ²Dr. Ashwini L.K,

¹M.tech Student, ²Assistant Professor,

¹Dr. Ambedkar Institute of Technology, Bengaluru, India

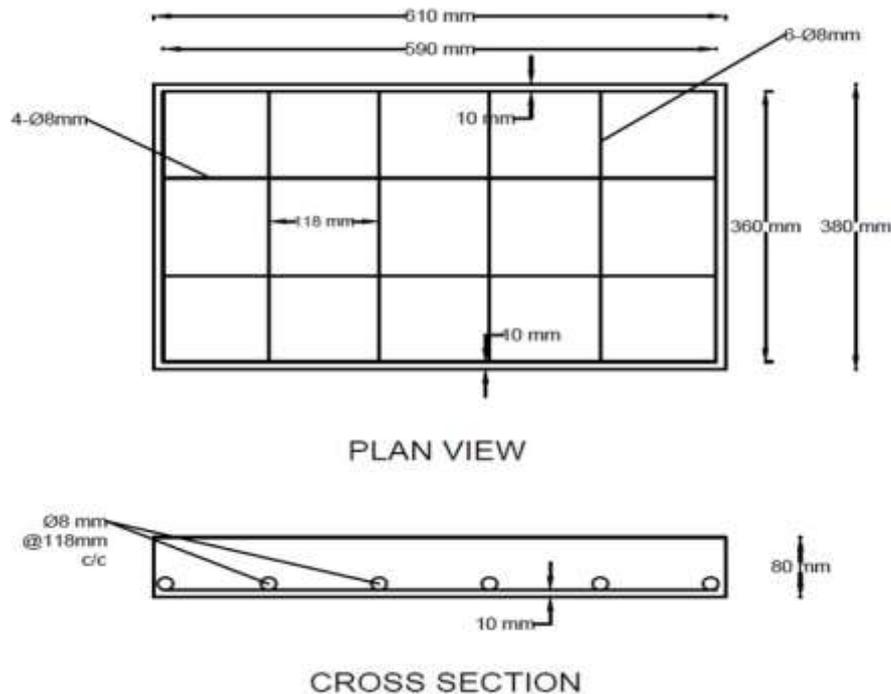
Fig 1: Slab reinforcement Schedule

. The slab was designed and cast with a mold dimension of 610 mm × 380 mm × 80 mm and a clear cover of 10 mm. Reinforcement consisted of six 8 mm diameter bars placed along the length at a spacing of 118 mm and four 8 mm diameter bars placed along the breadth at a spacing of 120 mm. Bar bending, cutting, and placement of reinforcement were carried out at the casting site to ensure accuracy and proper alignment before concreting.

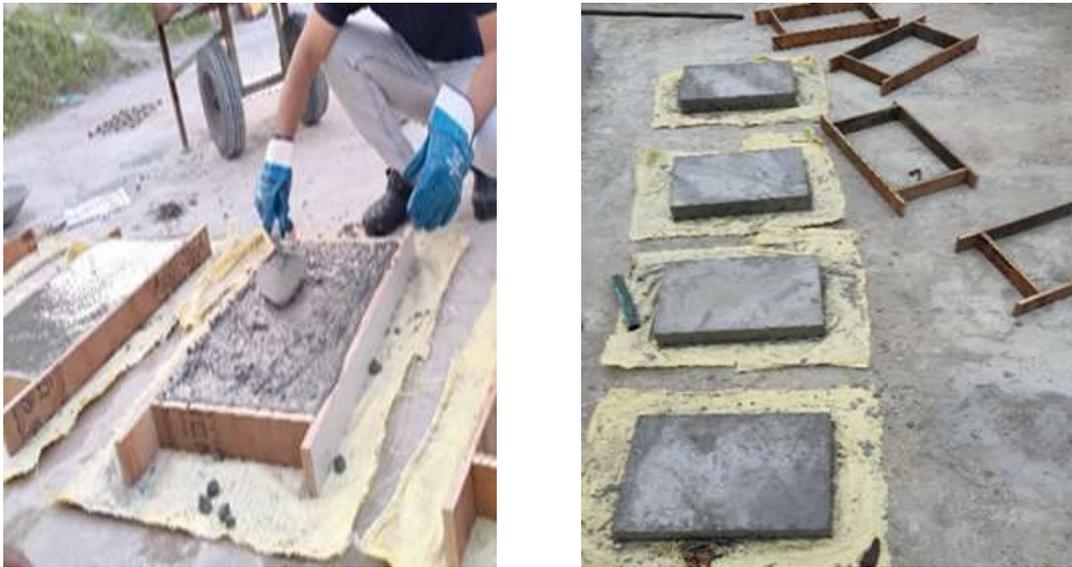
Fig 2: Casting of Slabs

The casting of both cement and geopolymer concrete slabs was carried out following standard laboratory procedures. For cement concrete slabs, an M25 grade mix was prepared using the weight-batching method to ensure accurate proportioning of materials. A slump test was performed, resulting in a true slump of 80 mm, confirming the desired workability. For geopolymer concrete slabs, an M40 grade mix was prepared with a 50:50 ratio of Class F fly ash and GGBS, activated using sodium hydroxide and sodium silicate solutions, with the alkaline activator solution prepared 24 hours prior to casting. In both cases, the molds were cleaned and oiled before placing the reinforcement and pouring the mix. The prepared mix was placed into the slab molds in layers, with manual tamping carried out to ensure compaction and uniformity. Care was taken to avoid segregation and honeycombing.

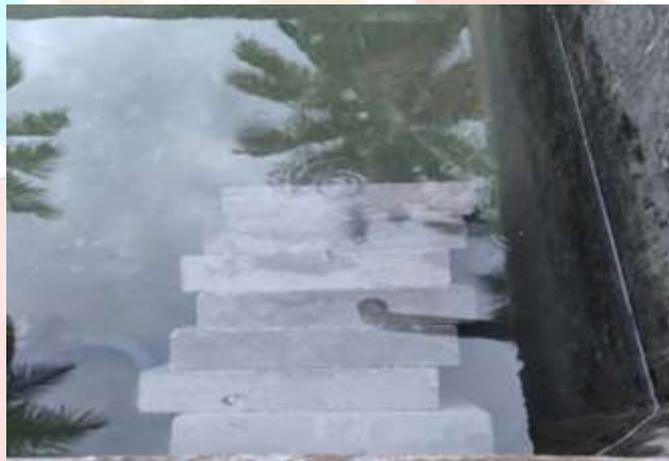
Both cement concrete and geopolymer concrete slabs were cured for 28 days water curing for cement concrete and ambient curing for geopolymer concrete. After curing, all slabs were demolded and stored under ambient conditions until testing.

Fig 3: Pond curing of Cement concrete slabs

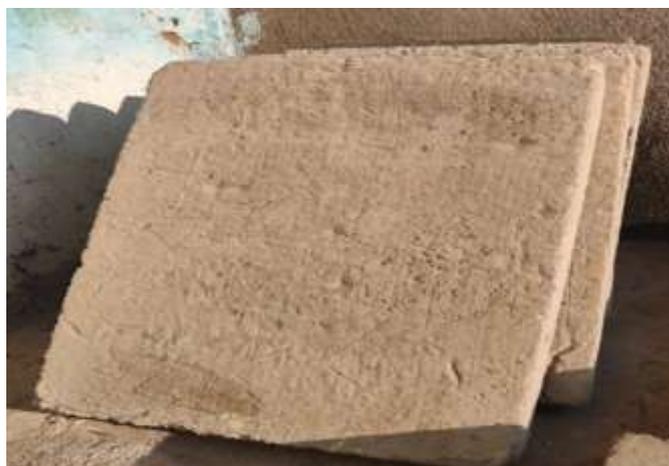
Fig 4: Ambient curing of Geopolymer concrete slabs

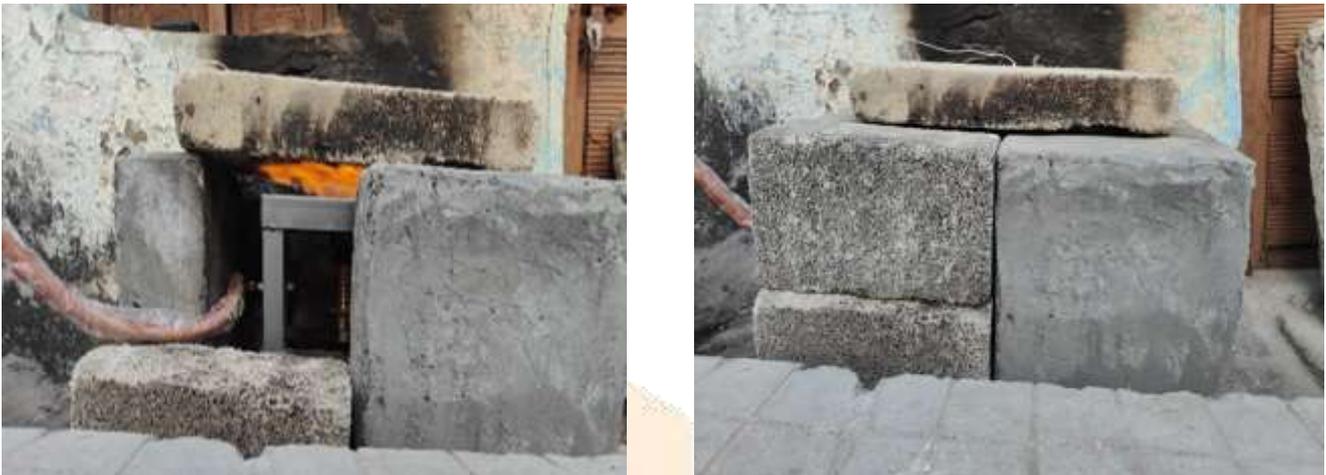
Fig 5: Fire set up

All slabs, both conventional cement concrete and geopolymer concrete, were subjected to controlled fire exposure to evaluate their behavior under elevated temperatures. Each slab was exposed to a temperature of 800 °C for a duration of 1 hour, replicating severe fire conditions. To ensure uniform heating and avoid heat loss, the fire setup was closed from all sides, creating a controlled furnace like environment around the slab. For internal thermal monitoring, a small hole was drilled at the center of each slab up to half of its thickness, into which the EUROLAB Digital Thermometer TM-902C with K-type thermocouple (−50 °C to +1300 °C range) was inserted. This arrangement allowed continuous and accurate measurement of the internal temperature of the slabs, while the external surface temperature was simultaneously observed to verify uniform heating. After completion of the heating cycle, all slabs were allowed to cool naturally under ambient conditions, replicating post-fire exposure scenarios.

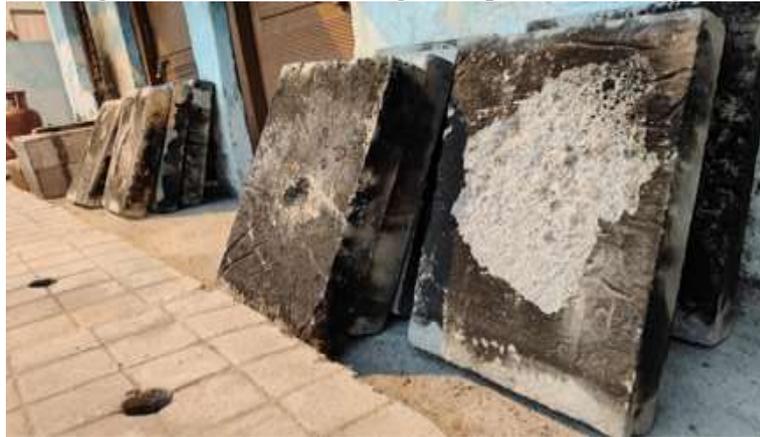
After exposure to fire, the cement concrete slab exhibited very extensive cracking across the surface, with cracks forming in multiple directions, indicating severe thermal stress. There was pronounced spalling, with pieces of the surface layer detaching, sometimes accompanied by a distinct loud cracking sound. The slab's color changed significantly, turning dark grey, which indicates decomposition of hydrated cement phases and surface dehydration. Some portions of the slab showed minor surface powdering due to intense heat. Overall, the damage was severe, with large areas of the slab losing structural integrity.

The geopolymer slab also developed substantial cracks, though they were relatively less extensive than in the cement slab. Slight spalling occurred, primarily near the edges, but the overall slab maintained better surface integrity. The slab turned dark grey as well, indicating surface thermal effects, but there was less fragmentation and no loud sounds, reflecting higher thermal stability. The geopolymer slab’s surface remained more cohesive, demonstrating better resistance to high-temperature damage compared to cement concrete.

Fig 7: Fire Damaged Cement and Geopolymer Slabs

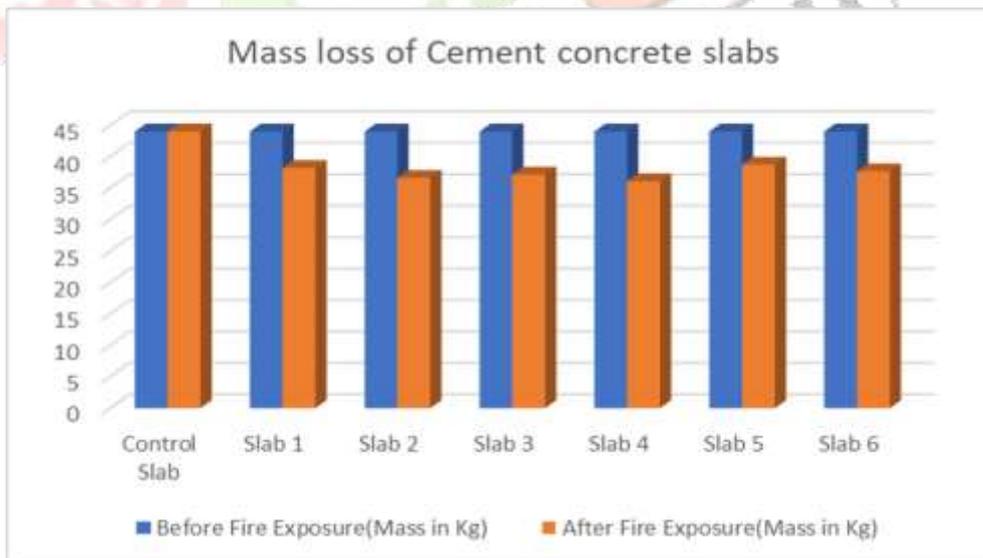
After exposure to elevated temperature of 800°C for 1 hour, both cement concrete and geopolymer concrete slabs exhibited significant reduction in mass due to evaporation of free water, dehydration of bound water, and thermal decomposition of hydration products. The cement concrete slabs recorded a higher mass loss of up to 18%, which can be attributed to severe spalling, cracking, and decomposition of calcium hydroxide (Ca(OH)₂) and calcium silicate hydrate (C-S-H) phases at high temperature. The escape of moisture from pores caused internal vapor pressure, leading to surface scaling and disintegration, thereby accelerating weight reduction. In contrast, the geopolymer slabs showed a comparatively lower mass loss of up to 14%, demonstrating better thermal stability. This behavior can be explained by the absence of portlandite in geopolymer matrices and the presence of aluminosilicate gel, which provides greater resistance against dehydration and thermal decomposition. The reduced weight loss of geopolymer slabs highlights their superior fire resistance, reduced spalling tendency, and enhanced structural integrity compared to conventional cement concrete under identical fire conditions.

Fig 8: Mass loss of Cement concrete slabs

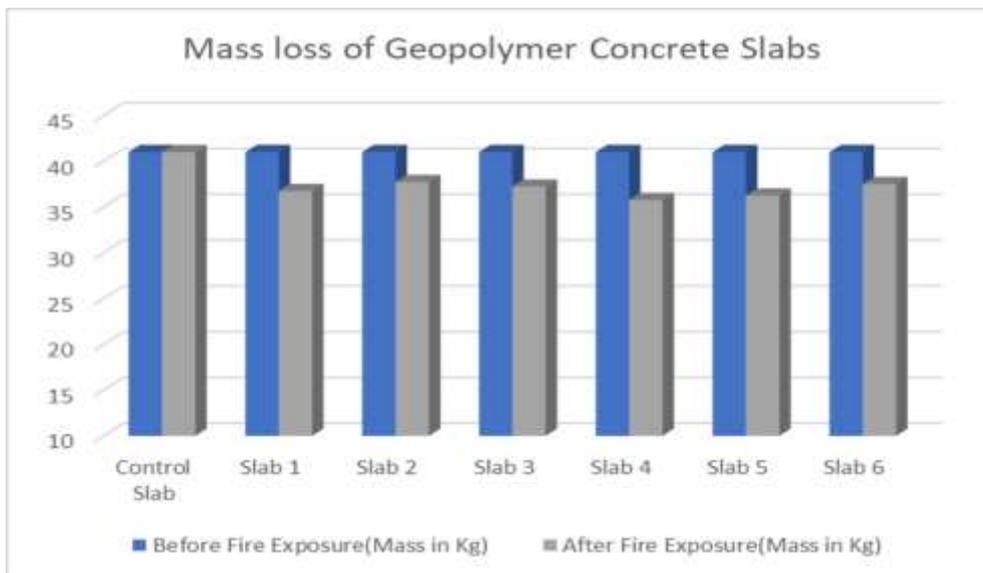
Fig 9: Mass loss of Geopolymer concrete slabs

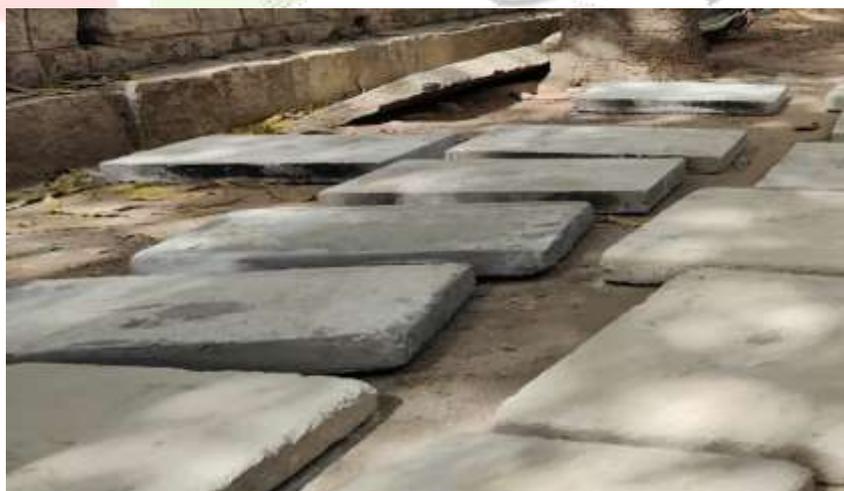
Fig 10: Repaired Slabs

After the completion of fire exposure, the deteriorated cement and geopolymer concrete slabs were subjected to a repair process to restore their structural integrity prior to retrofitting. The damaged and weakened concrete surface layers were first cleaned thoroughly to remove all loose particles, dust, and charred material generated due to fire. Edges of the cracks and spalled regions were carefully trimmed to achieve a sound substrate and improve the bonding efficiency of the repair mortar. A polymer-modified repair mortar (Sika Monotop 122F) was then applied to the damaged regions of both cement and geopolymer slabs. This repair mortar was selected due to its superior adhesion, shrinkage control, and enhanced mechanical performance compared to conventional mortars, making it suitable for repairing thermally degraded concrete surfaces. The mortar was carefully packed into the prepared cavities and over the affected surfaces in successive layers to ensure full coverage and void-free compaction. After application, the repaired slabs were kept under moist curing for 14 days to facilitate proper hydration of the polymer-modified mortar and achieve the required strength gain. This repair phase effectively restored the surface profile, reduced crack widths, and provided a uniform substrate for the subsequent retrofitting process, thereby enhancing the durability and load-bearing capacity of the fire-damaged slabs.

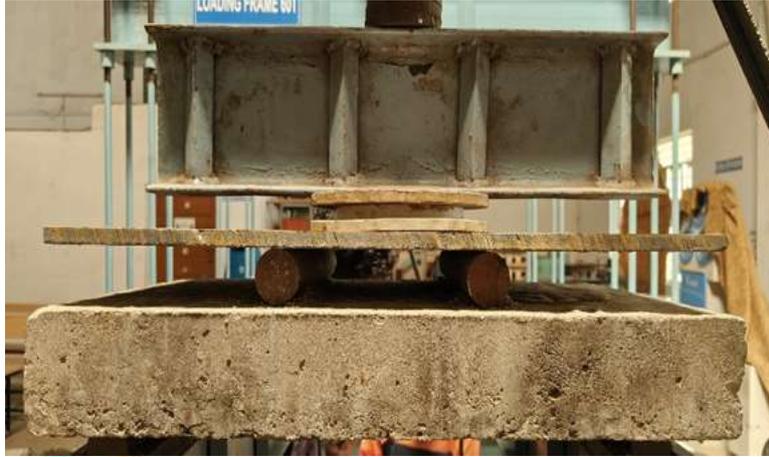
To evaluate the residual strength and behavior of the slabs after exposure to elevated temperatures, a four-point static load test was carried out on the fire-damaged cement and geopolymer concrete slabs. The test aimed to determine their ultimate load-carrying capacity, stiffness, and deflection characteristics before undertaking any retrofitting measures. This assessment provided a baseline for understanding the extent of strength loss due to fire damage and for comparing the effectiveness of subsequent repair and strengthening techniques.

Fig 11: Testing of fire damaged before retrofitting

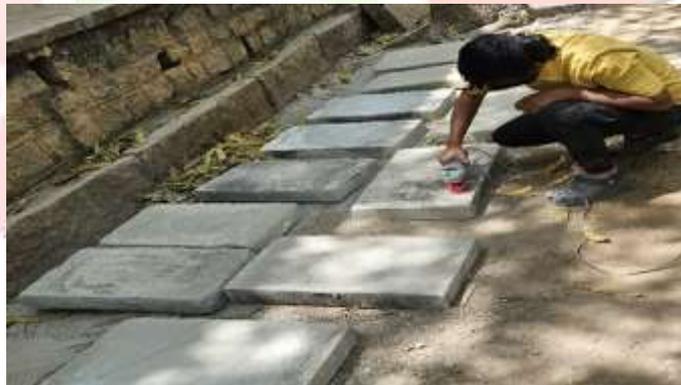
. After completion of the load testing, the slabs were subjected to surface preparation prior to retrofitting with FRP laminates. The concrete surface was treated using a angle grinder to remove any laitance, loose particles, and irregularities, thereby ensuring a smooth and uniform bonding surface. Following grinding, the accumulated dust and fine particles were completely removed using an electric air blower to achieve a clean and dry surface. This process ensured proper adhesion of the epoxy resin and enhanced the bond strength between the FRP laminates and the concrete substrate.

Fig 12: Surface preparation of slab by grinding method

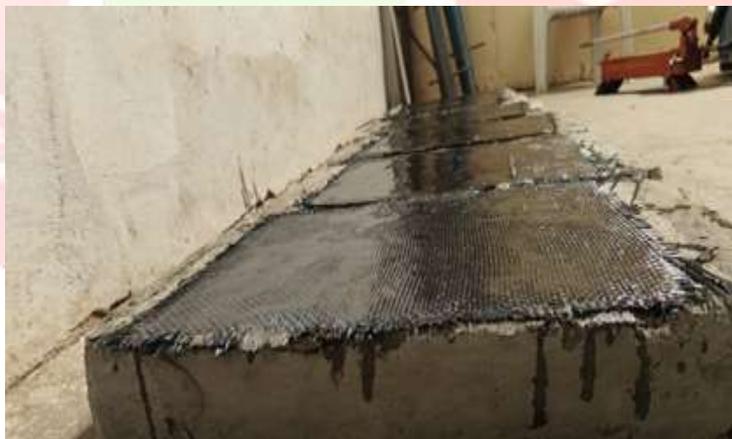
For retrofitting, Araldite LY 556 epoxy resin and Aradur HY 951 hardener were prepared in the recommended ratio of 100:10 by weight. The two components were thoroughly mixed in a clean container until a homogenous and consistent blend was achieved, ensuring no air entrapment during stirring. The prepared epoxy adhesive was applied uniformly only on the soffit (bottom surface) of the slabs as well as on the bonding face of the FRP laminate. The laminate was then carefully positioned on the soffit and pressed firmly against the surface to achieve full contact and to expel any air pockets. A roller was used to provide uniform pressure, thereby improving the adhesive distribution and bond quality. After placement, the slabs were kept undisturbed under ambient conditions for a curing period of 14 days to allow complete development of adhesive strength. This ensured a durable bond between the soffit surface of the concrete slabs and the FRP laminates, which is essential for enhancing the load-carrying capacity and overall performance of the retrofitted slabs.

Fig 13: Application of FRP on slab surface with the use of Epoxy adhesive

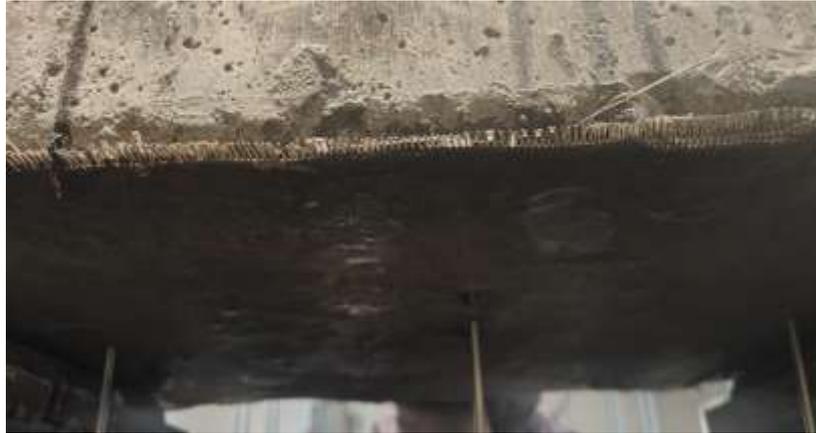
The strengthened slabs were tested under two-point loading to evaluate their ultimate load bearing capacity. The load–deflection behavior was carefully recorded to assess the effectiveness of FRP retrofitting in enhancing strength and stiffness.

Fig 14: Testing of FRP strengthened slab

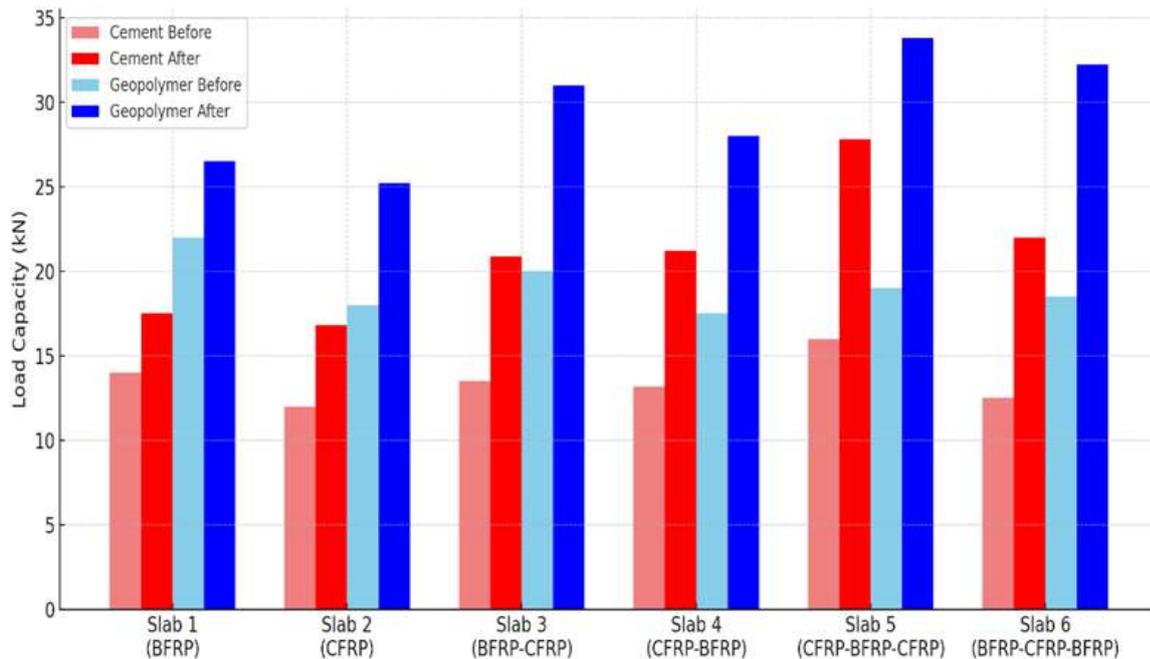
The experimental results clearly indicate that geopolymer concrete slabs exhibited superior performance compared to cement concrete slabs under retrofitting. While both slab types showed a noticeable increase in ultimate load capacity after the application of different FRP systems, the percentage increase was consistently higher in geopolymer slabs. For instance, in hybrid configurations such as CFRP–BFRP and BFRP–CFRP, geopolymer slabs achieved ultimate loads exceeding 30 kN, whereas cement slabs remained below this range even after retrofitting. This difference highlights the inherent strength and durability of geopolymer concrete, which provided a better bonding surface and enhanced composite action with FRP laminates. Overall, the results demonstrate that geopolymer slabs not only retained higher initial capacities before retrofitting but also benefited more effectively from strengthening, making them a more sustainable and resilient alternative to conventional cement concrete slabs.

Fig 15: Load bearing capacity of cement and geopolymer concrete slabs before and after retrofitting

The fire-damaged cement slabs showed a considerable improvement in load-bearing capacity after retrofitting with different FRP configurations. Before retrofitting, the maximum load values ranged from 12.0 kN to 16.0 kN, depending on the type of strengthening system. After retrofitting, the values increased significantly, reaching up to 27.8 kN in the case of the CFRP–BFRP–CFRP configuration. The percentage increase in load capacity varied between 25% and 73%, with the highest gain observed in multi-layer hybrid systems. This clearly demonstrates that retrofitting with hybrid FRP laminates is highly effective in restoring and even enhancing the strength of damaged cement concrete slabs, providing them with a renewed structural capacity.

In the case of geopolymer slabs, the effect of retrofitting was even more pronounced compared to cement slabs. The initial load-bearing capacity of the fire-damaged slabs ranged from 17.5 kN to 22.0 kN, which increased substantially after strengthening, with the highest value reaching 33.8 kN under the CFRP–BFRP–CFRP arrangement. The percentage increase in strength was observed between 20% and 73%, with the maximum enhancement again found in hybrid multi-layer systems. These results confirm that geopolymer concrete not only withstands fire exposure better than cement concrete but also responds more effectively to FRP retrofitting, making it a superior alternative for sustainable structural rehabilitation.
