GEOSPATIAL INPUTS FOR IRRIGATION EFFICIENCY IN THE COMMAND AREA OF TUNGABHADRA LEFT BANK CANAL

¹A World bank funded project - KWDP-II Sujala-III under Watershed Dept GoK, University of Agricultural Sciences, GKVK, Bangalore, India.

Abstract –Irrigation of crops consumes a substantial quantity of water and that must be used judiciously. The study reported here is an attempt to understand the role of satellite remote sensing and GIS in improving the irrigation efficiency of canal irrigation. The main objective of this paper is to identify the gaps between the irrigation potential created and utilised and suggesting new canals to the gap identified areas in order to increase the irrigation by using high resolution satellite data, SOI toposheets, slope and DEM to the Tungabhadra left bank command area, finding the cropping pattern violations and degraded lands.

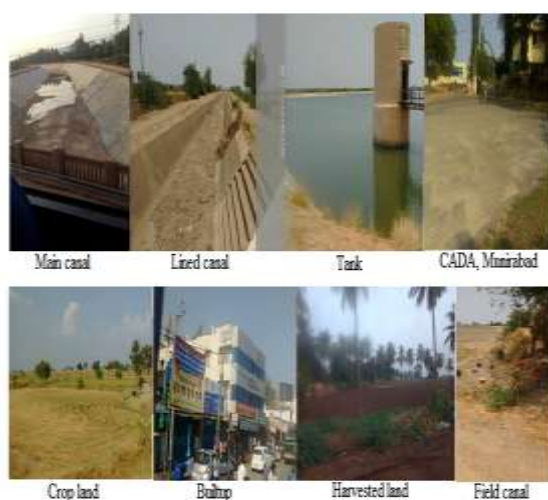
Figure.1: Some of the ground truth points collected in the study area and the Toposheets used for the TLBC Command area

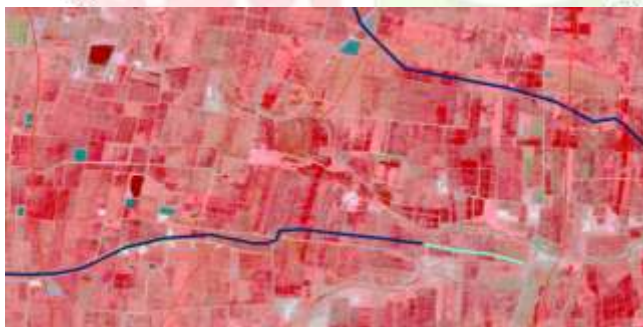
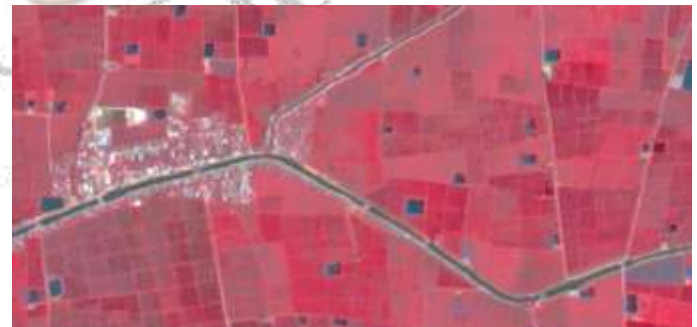
- (a) shows sample image of LISS-4 merged with Cartosat-1+PAN indicating Canal network in the command area.
 (b) The gap in the canal (Cyan colour line) identified on the satellite image.

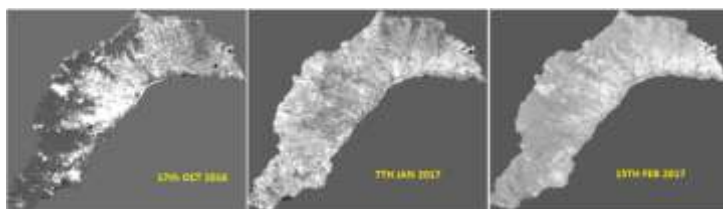
Figure.9:The Normalized Difference Moisture Index (NDDI) for different months

$$\text{NDDI} = \text{NDVI} - \text{NDMI} / \text{NDVI} + \text{NDMI}$$
