ENDODONTIC MANAGEMENT OF FURCATION PERFORATION IN MANDIBULAR FIRST MOLAR WITH BIODENTINE: CASE REPORT

Keywords - Furcal perforation, Biodentin, mandibular first molar.

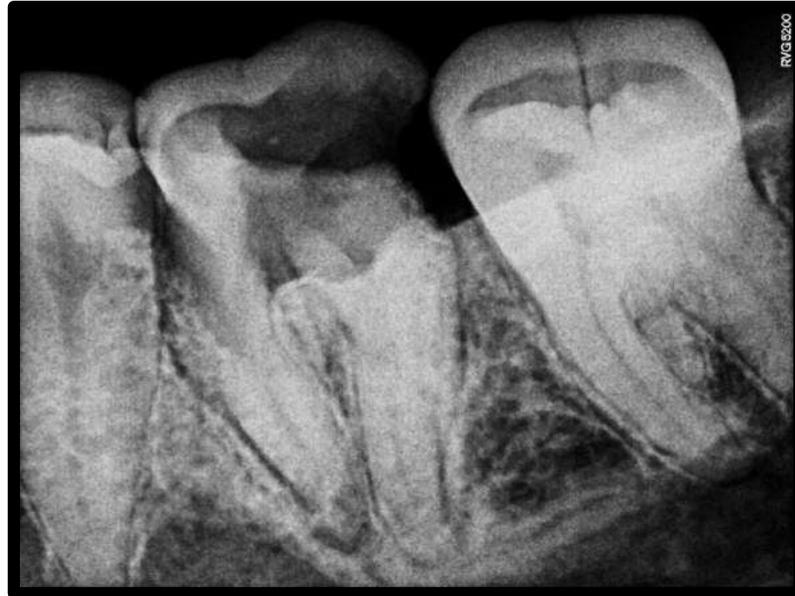
Fig.1: Preoperative Radiograph

A 45-year-old woman reported with pain in relation to left lower back tooth region since 3 days. Looking into the history it was recorded that patient had undergone a procedure for root canal treatment of mandibular 1st molar on that side around 1 week back from a local dentist. Presently the pain was continuous, aggravated on chewing food and was relieved on taking medication. Periradicular radiographic examination revealed a little radiolucent area in the furcal region of left first mandibular molar and apical radiolucency's from pulp necrosis were also observed [Figure 1]. Several treatment options were discussed with the patient and she opted for non-surgical endodontic treatment of the tooth along with perforation repair.

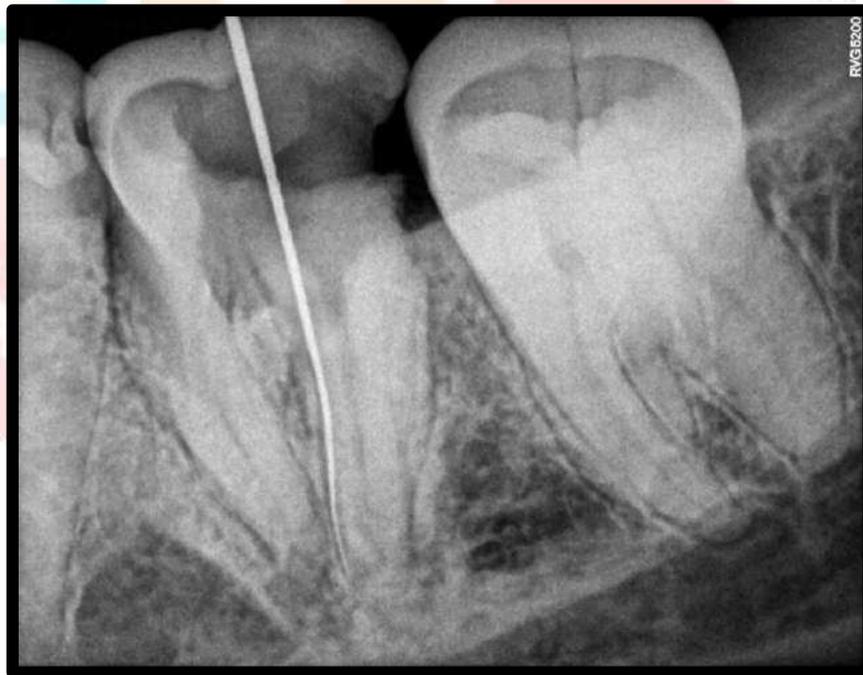
Fig.2: Assessment of perforation

After administration of local anesthesia, 2% lidocaine 1:100000, the tooth was isolated with a rubber dam, temporary restorative material was removed and the access cavity was prepared so that perforation area could be clinically seen (Figure 2,3). Hemorrhage was controlled with copious irrigation of 0.9% saline solution. A cotton pellet was placed in the orifice of perforation. The working length was then checked by using an apex locator and radiovisiography (Figure 4). The root canals were cleaned and shaped using K- files (Dentsply) in a step back technique.

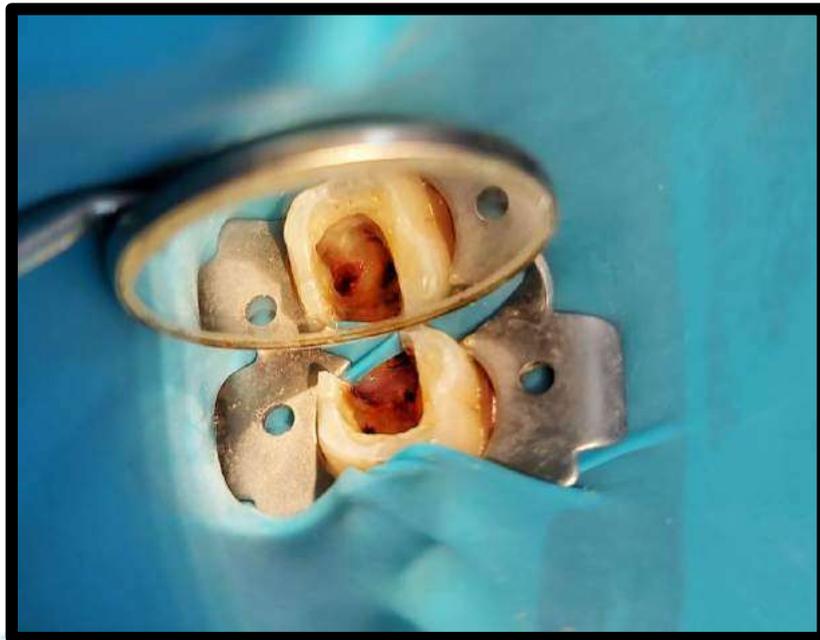
Fig.3: Site of perforation

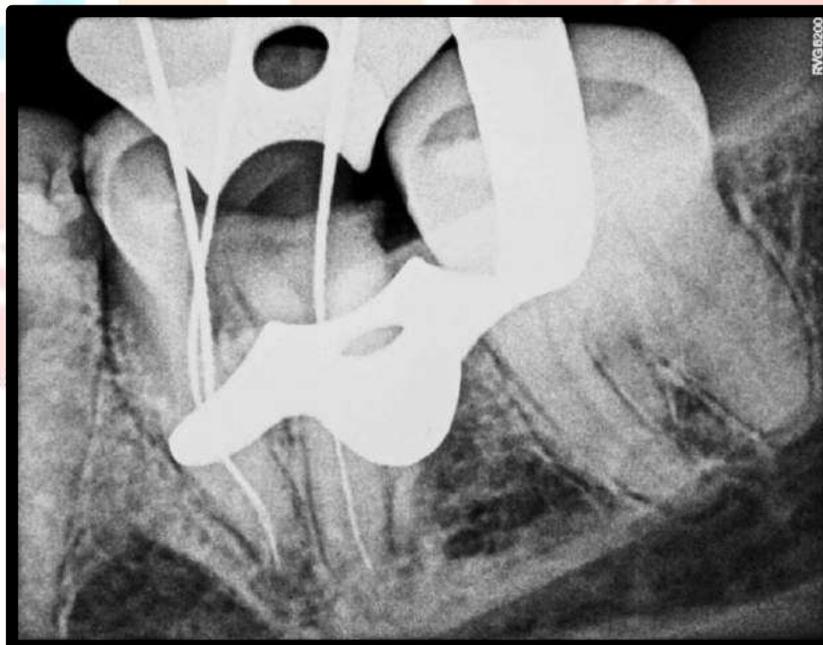
Fig.4: Working length determination

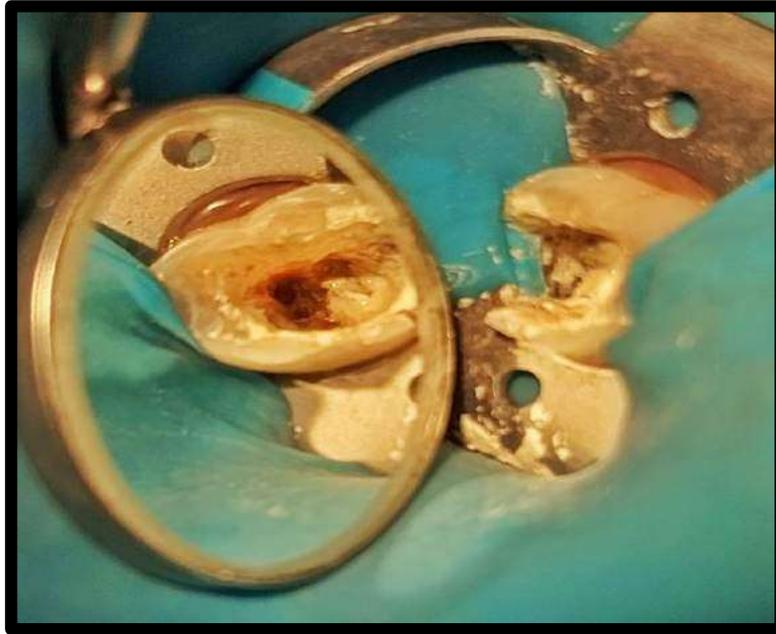
Fig.5: Biodentin is placed at the site of perforation

After obturation of the root canals, cotton pellet was removed from the perforation, exposing the site of perforation. The furcal perforation was irrigated with saline solution and 2% Chlorhexidine, Biodentine was mixed on a paper pad, and the perforation site was repaired by condensing Biodentine in the area (Figure 5). Patient was recalled after 1 week for post endodontic composite restoration. Radiograph obtained after the restoration confirmed that perforation had been sealed (Figure 6). The patient was completely asymptomatic

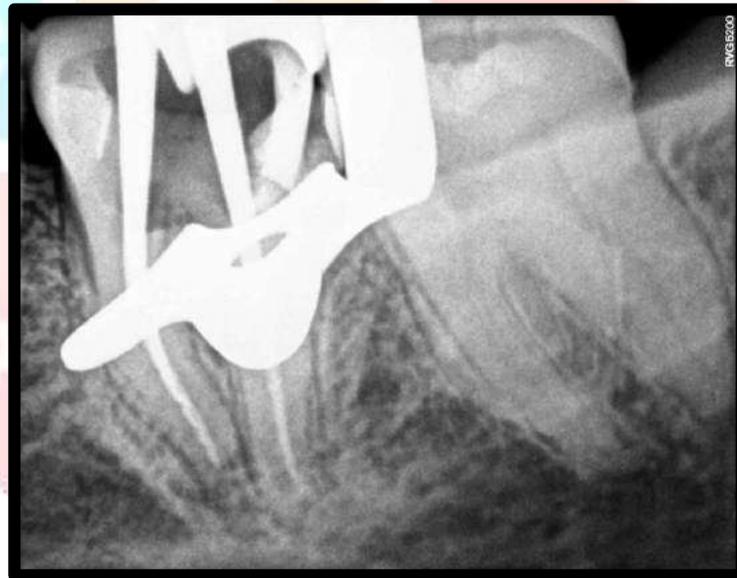
Fig.6: Master cone selection

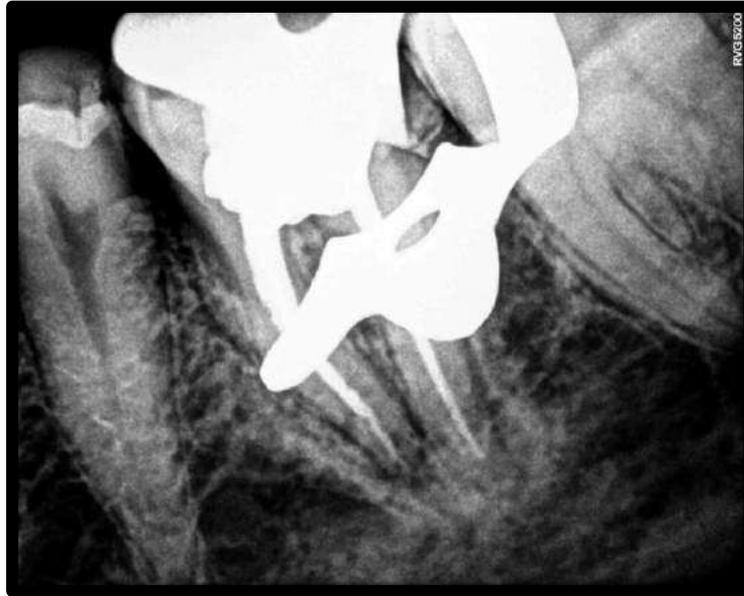
Fig.7: Post obturation radiograph

At two-year follow up, the tooth was asymptomatic and clinical examination revealed that the tooth had no pain or no tenderness on percussion and palpation. No attachment loss was seen as indicated by normal probing depths. The tooth revealed adequate clinical function, and radiographic findings showed adequate sealing of the perforation site with no radiolucency finding at the furcation area and satisfactory healing of the periapical lesions.
